HOME REPORT

40 FINDHORN
FORRES
IV36 3YE

Energy Performance Certificate (EPC)

40, FINDHORN, FORRES, IV36 3YE

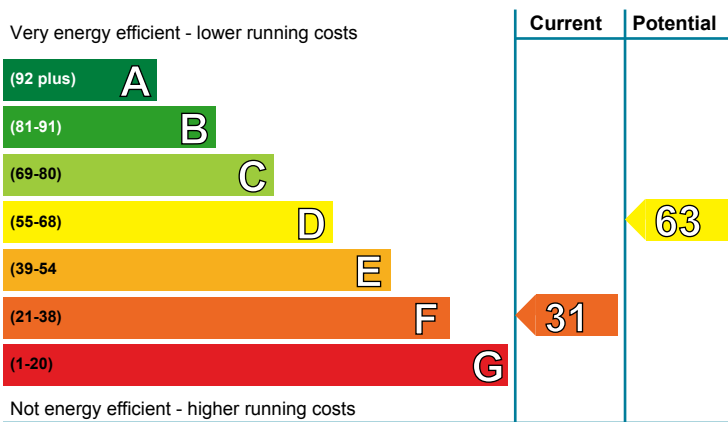
Energy Efficiency Rating

This graph shows the current efficiency of your home, taking into account both energy efficiency and fuel costs. The higher this rating, the lower your fuel bills are likely to be.

Your current rating is **band F (31)**. The average rating for EPCs in Scotland is **band D (61)**.

The potential rating shows the effect of undertaking all of the improvement measures listed within your recommendations report.
