HOME
report

SINGLE SURVEY
ENERGY REPORT
PROPERTY QUESTIONNAIRE
VALUATION REPORT

Single Survey

Property Address	Tucker Cottage Main Road Alves Elgin IV30 8UR
Customer	Mr J Jackson
Date of Inspection	04/07/2025
Prepared by	Donna Shields Harvey Donaldson & Gibson Chartered Surveyors

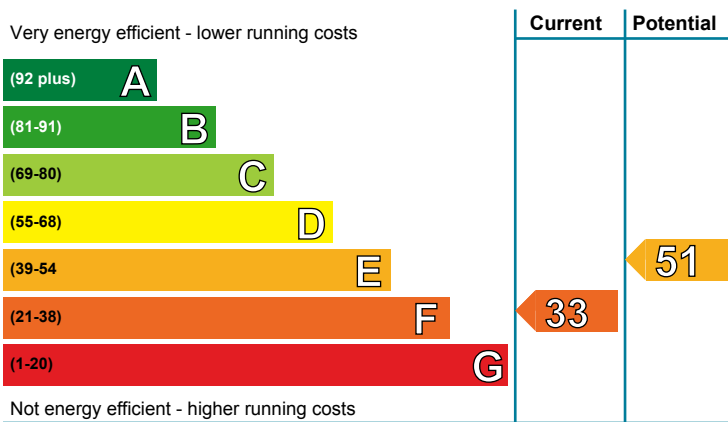
Energy Efficiency Rating

This graph shows the current efficiency of your home, taking into account both energy efficiency and fuel costs. The higher this rating, the lower your fuel bills are likely to be.

Your current rating is **band F (33)**. The average rating for EPCs in Scotland is **band D (61)**.

The potential rating shows the effect of undertaking all of the improvement measures listed within your recommendations report.

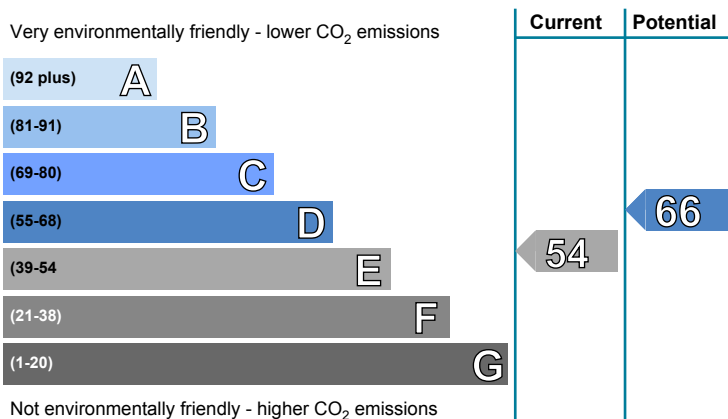
Environmental Impact (CO₂) Rating

This graph shows the effect of your home on the environment in terms of carbon dioxide (CO₂) emissions. The higher the rating, the less impact it has on the environment.
